# **A Practical Look At Comparing Puget Sound LIDAR Consortium (PSLC) Data to Field Survey Points Within A Photogrammetric Soft Copy Stereo Model.**

**Report By Kurt Iverson and Jason Goldstein, WSDOT,  
Geographic Services.  
5-20-03**

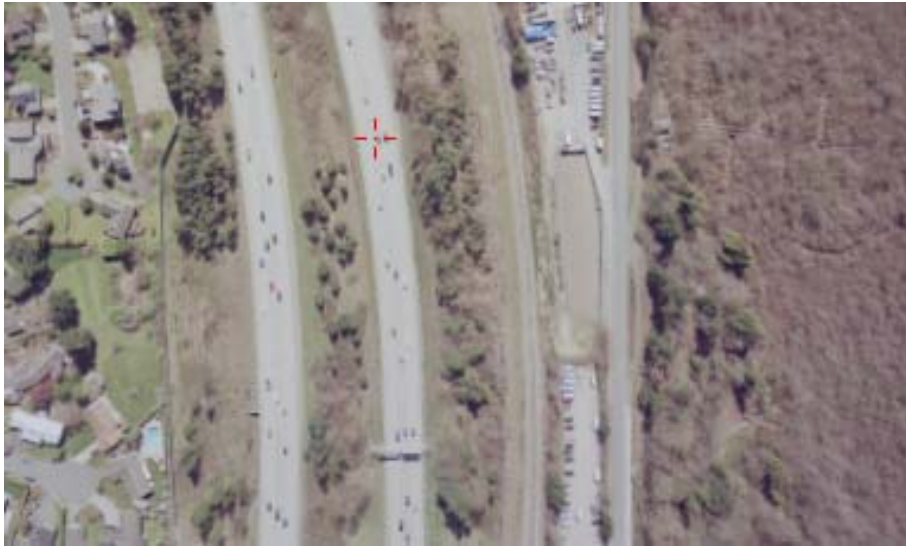
WSDOT Geographic Services large scale, high accuracy photogrammetric design mapping data (seen below), and specific field survey data was used to validate the LIDAR data.

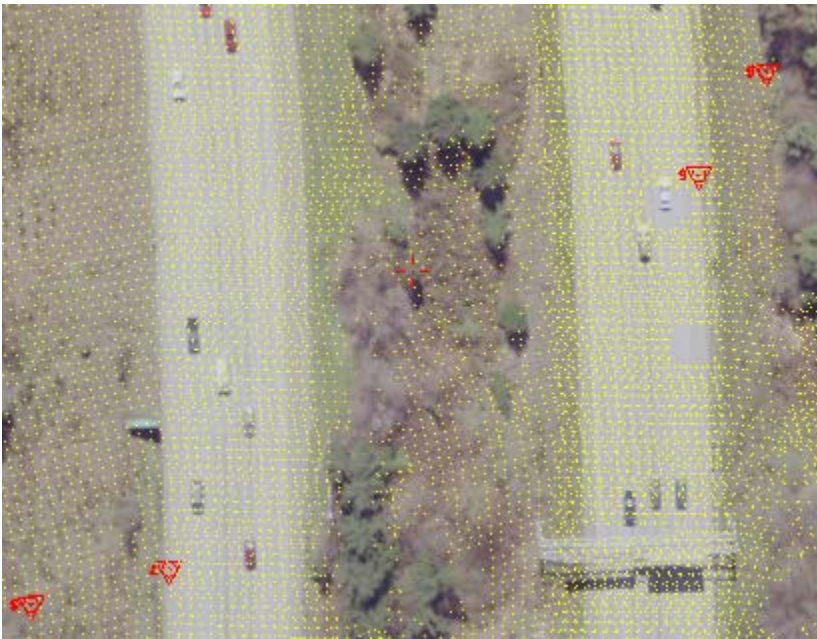
*Bare ground PSLC xyz LIDAR data draped within a stereo model (two overlapping stereo photos 9"x9") in a soft copy 3.D. mapping system*

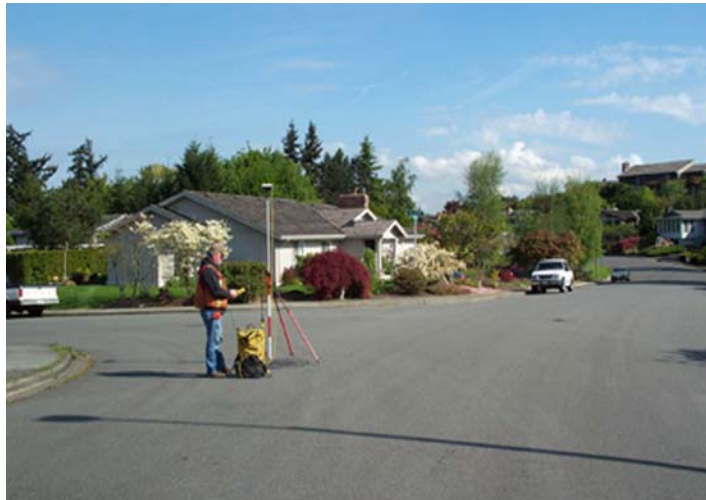
*QC1*-Manhole cover in paved street at intersection of SE 20th/121 Ave. SE.

LIDAR vertical differences: +0.22ft.

LIDAR horizontal point proximity to survey point: 1.76ft.

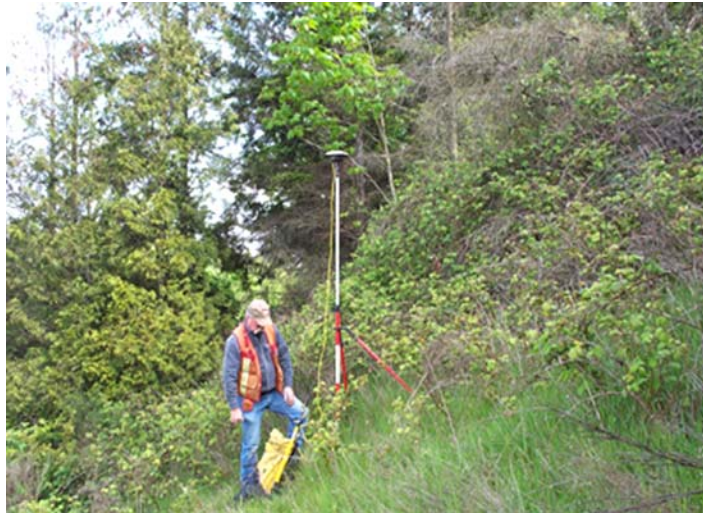
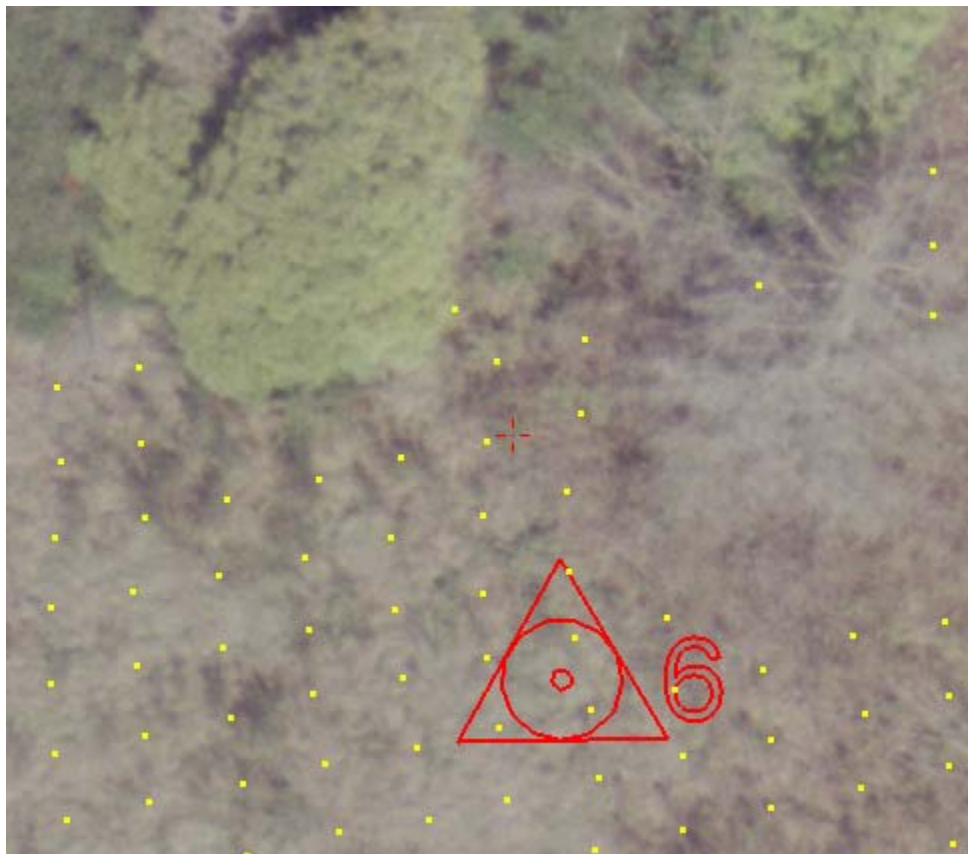
QC6-East side of SR405, halfway up the hillside in knee-high grass, surrounded by brush and trees.

LIDAR vertical differences: +0.97ft.

LIDAR horizontal point proximity to survey point: 2.2ft.

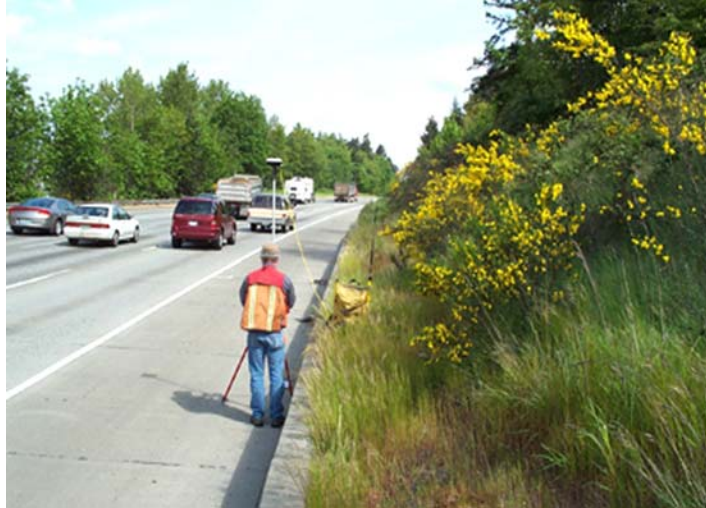
QC7-East side of SR405 on the pavement near a retaining wall. Transportation corridor landscape. Trees and obstructions to the east.

LIDAR vertical differences: +0.30ft.

LIDAR horizontal point proximity to survey point: 0.27ft.

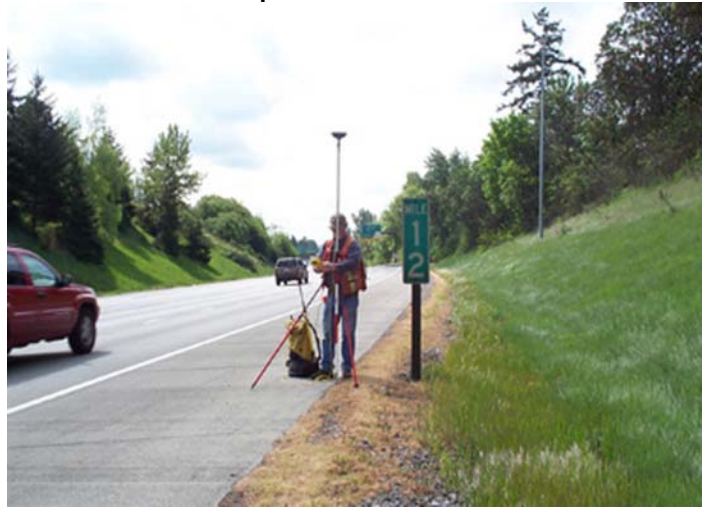
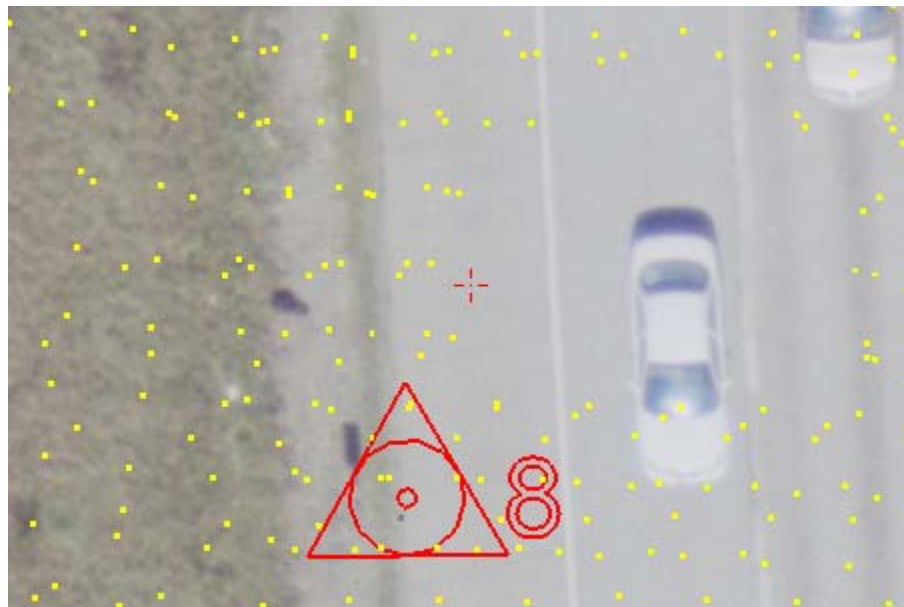
*QC8* West side of SR405, southbound lanes, on the edge of pavement at MP12. Transportation corridor landscape. No obstructions.

LIDAR vertical differences: +0.31ft.

LIDAR horizontal point proximity to survey point: 1.3ft.

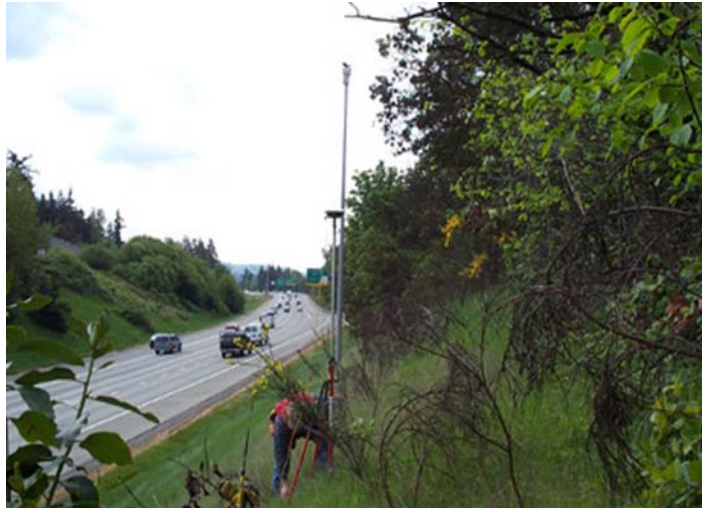
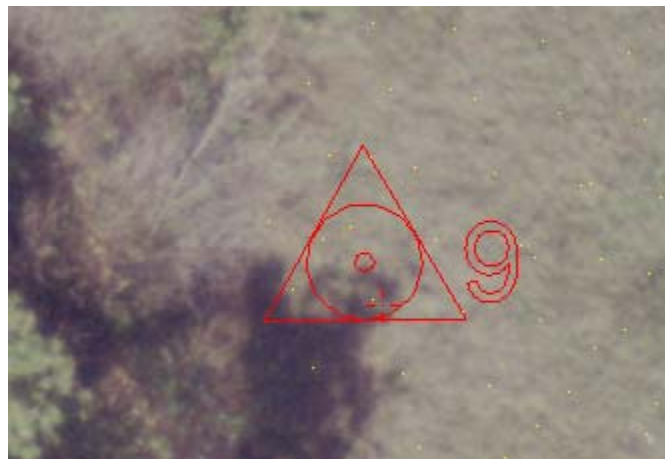
*QC9* West side of SR405, southbound lanes, near the top of slope, in 12" high grass at the westerly tree line. Transportation corridor landscape.

LIDAR vertical differences: -0.51ft.

LIDAR horizontal point proximity to survey point: 2.1ft.

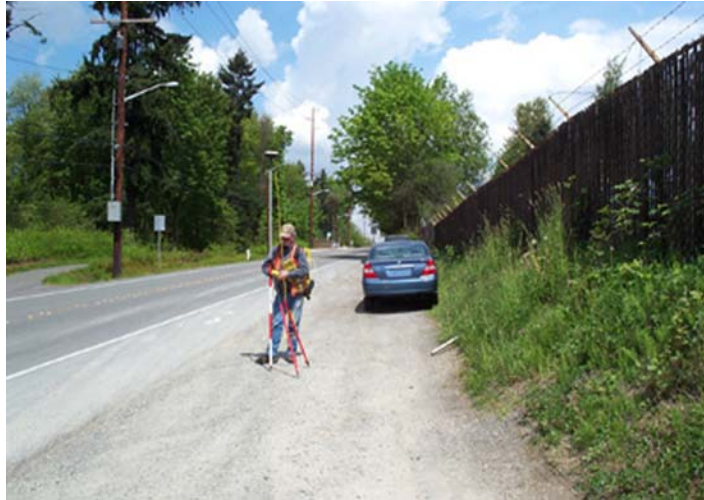
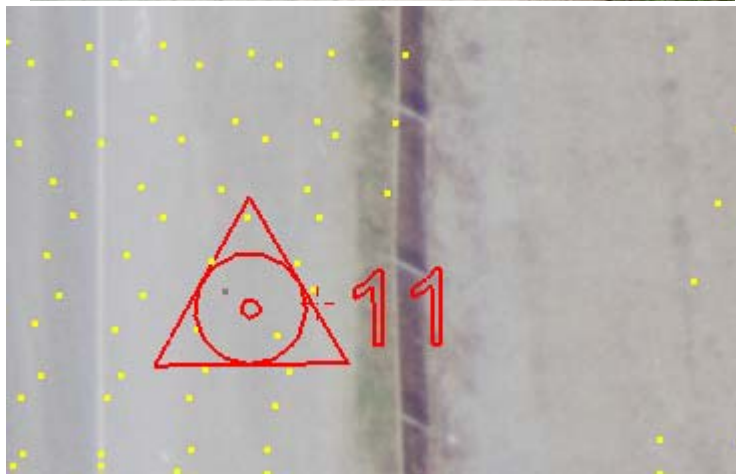
*QC11*-East edge of city street, in a gravel pull out. Embankment and tall fence in an easterly direction. Residential transportation landscape.

LIDAR vertical differences: +0.07ft. & +0.34ft.

LIDAR horizontal point proximity to survey point: 2.5ft. & 1.86ft.

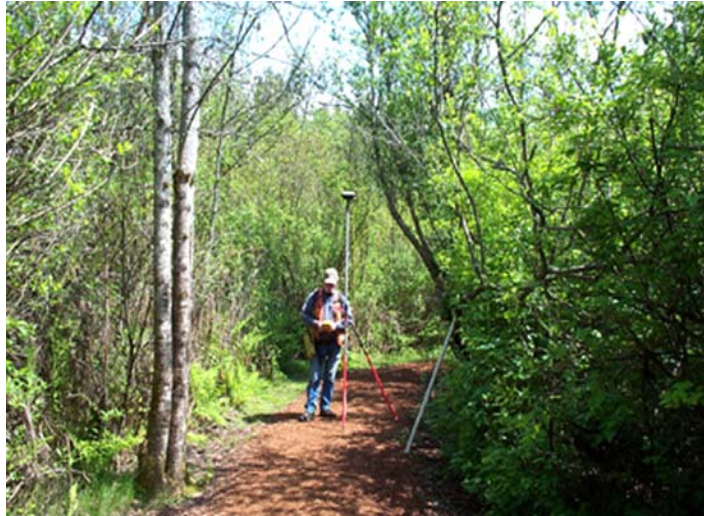
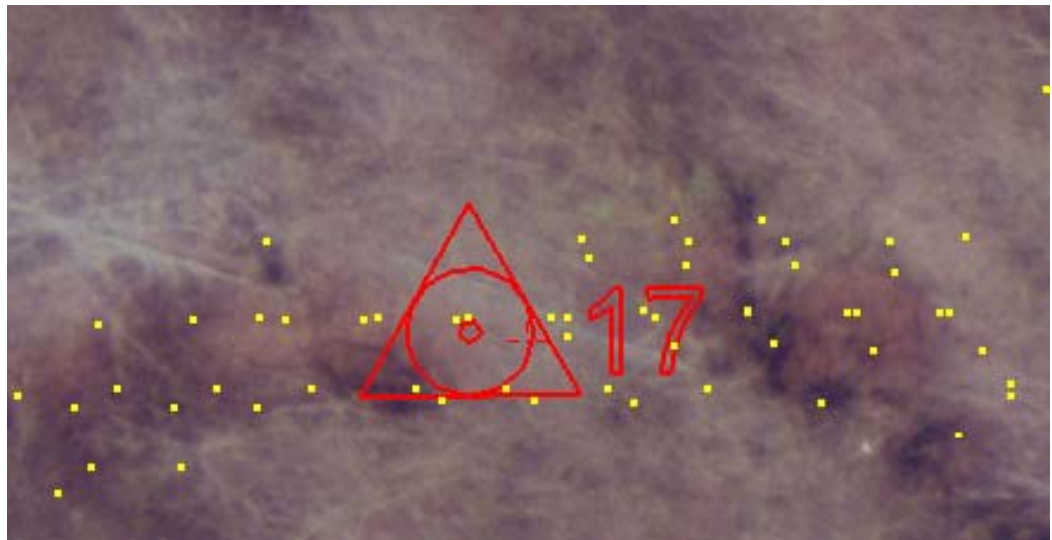
*QC17*-Ground surface of wood chip trail, entirely surrounded by tall trees. Very obstructed. Marshland riparian landscape.

LIDAR vertical differences: +0.34ft. & -0.12ft.

LIDAR horizontal point proximity to survey point: .09ft. & .09ft.

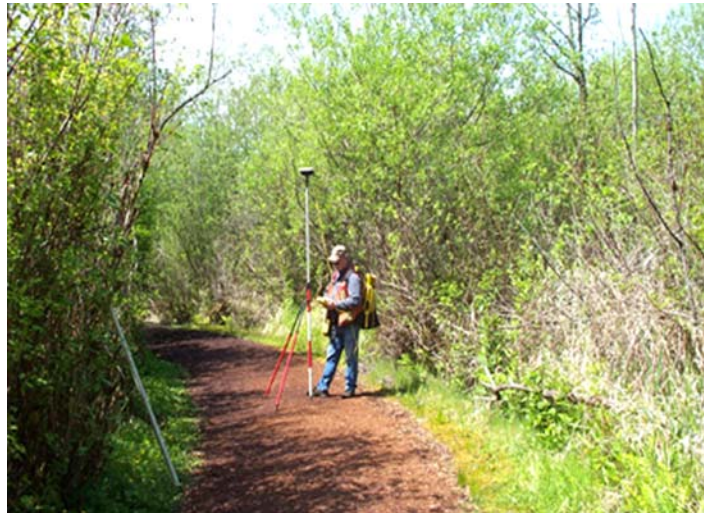
*QC18*-Ground surface of wood chip trail, surrounded by tall trees. Obstructed. Marshland riparian landscape.

LIDAR vertical differences: +0.45ft. & +1.79ft.

LIDAR horizontal point proximity to survey point: 1.18ft. & 8.1ft.

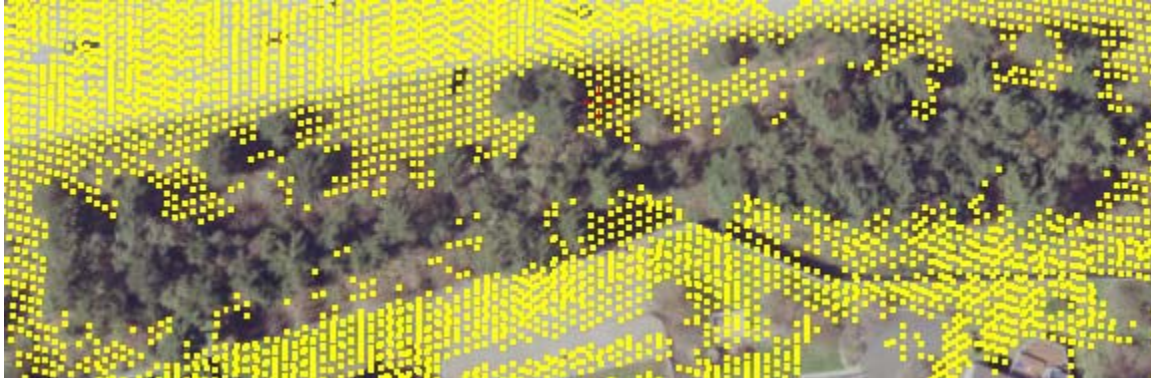
Heavy tree cover, with heights from 20 to 40+ feet prevented pulses from penetrating the ground. The PSLC data covering forested areas, of this type was devoid of data as seen below:

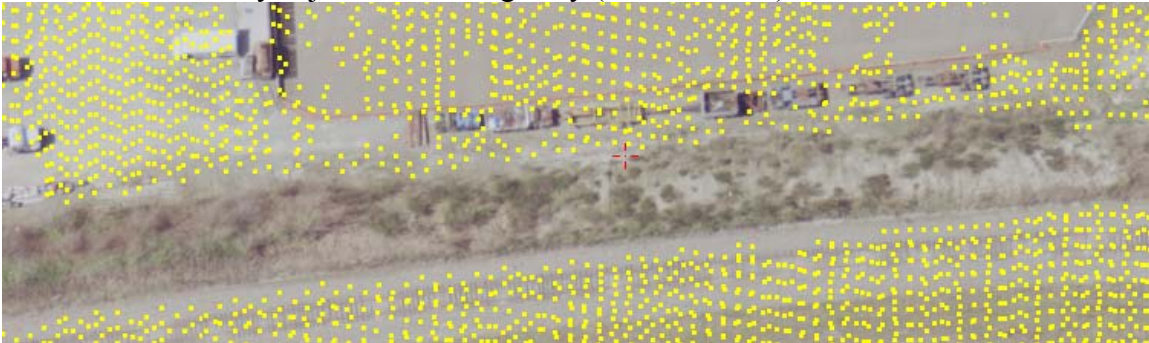
The PSLC data appeared to have incorrectly stripped out an entire 5-foot high embankment directly adjacent to the highway (visible below).
